# Improving Highway Safety: Cable Median Barrier

January 2004

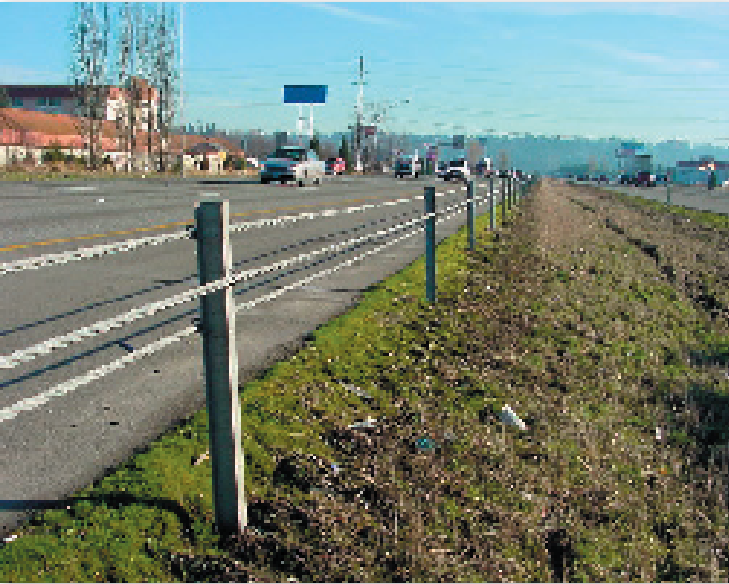
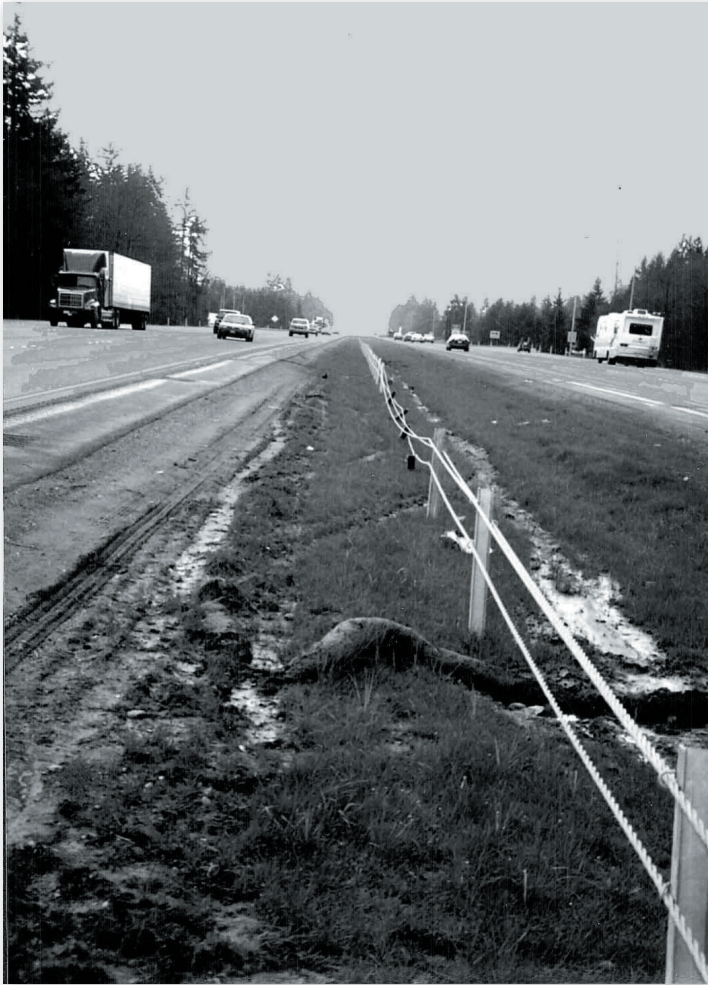
Typical cable median barrier installation and details
